# **MaineDOT Fish Passage Policy and Design Guide: 2003 Annual Report**

**March 2004**

**MaineDOT Fish Passage Steering Committee**

## **Second Annual Report: March 2004**

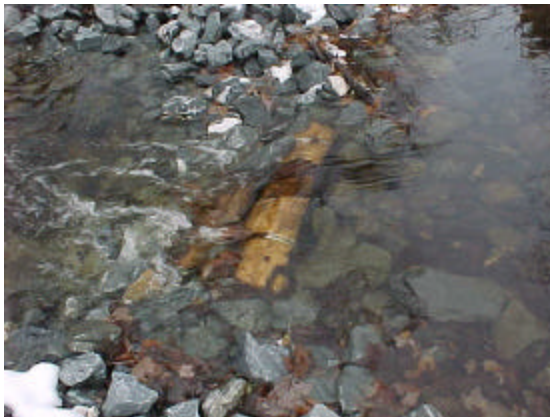
#### **Linneus, Bither Brook Bridge #3709, PIN 10049.00, Rte 2A over Bither Brook (2003)**

**Linneus: Log Drop Structure**

**Prior Condition:** Existing 103' long 9' diameter steel pipe with 0.4% slope. Bottom of pipe heavily rusted with some holes. Inadequate water depth inside pipe during summer and 6" +/- drop at outlet.

**Current Condition:** Sliplined with 8' diameter aluminum pipe. Concrete weirs and baffles added inside pipe to insure adequate depth of water. Two log drop grade control structures (\$2000 each) installed downstream to eliminate drop at outlet. Project completed 10/03 at total cost of about \$157,000 including engineering.

**Future action:** Post construction monitoring to begin in 2004.

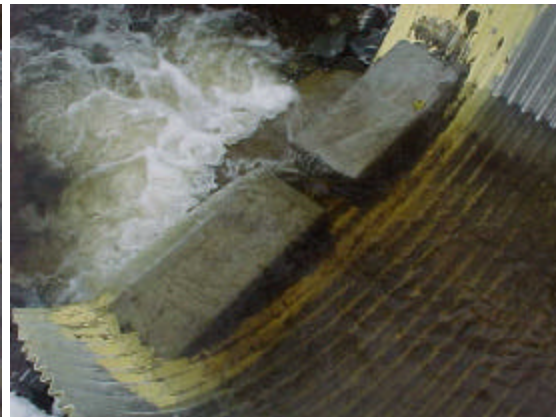
**Linneus: Looking down on Weir**

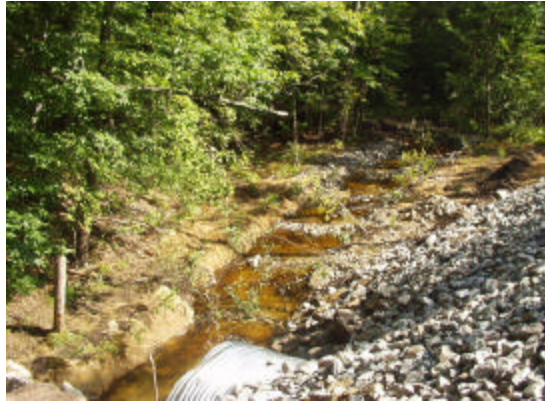
Sebago 2003. Photo by R. Hodgman.

**Prior condition:** Granite box culvert with outlet baffle sluice, not maintained and not effective. Invert elevation approximately 2' above normal high water mark of Sebago Lake. Meander in upstream channel of Batchelder Brook in contact with road, causing constant potential for erosion into brook. Proposed design - relocate portion of brook, install 4 log drop weirs (riffle-pool) to allow fish passage and as grade control for flows in shortened channel.

**Current condition:** New 9' diameter corrugated aluminum pipe, embedded (after removing ledge) 1' below normal high water mark of Sebago Lake. Final design substituted granite notch weirs for log drop structures to reuse material from demolition of granite box and reduce future maintenance needs. New culvert designed with 3% gradient. Slightly more ledge removed during construction than anticipated resulting in 2.5% gradient. New channel graded to match. Lower inlet invert required 2 additional weirs, for a total of 6 upstream. Riparian zone between new channel and roadway toe of slope revegetated with variety of plants for future channel shading. New channel currently stable after several rain events and high flows including a  $Q^{1.5}$  event on 10/28/03. Channel evolving as sediment loads from upstream areas migrate through system, changing pool and riffle depths as channel moves towards equilibrium. Trout observed in new channel.

**Future action:** Monitoring over the next couple of years will include observation of channel evolution and potential for *salminoid* and/or adult smelt migration to upstream habitat.

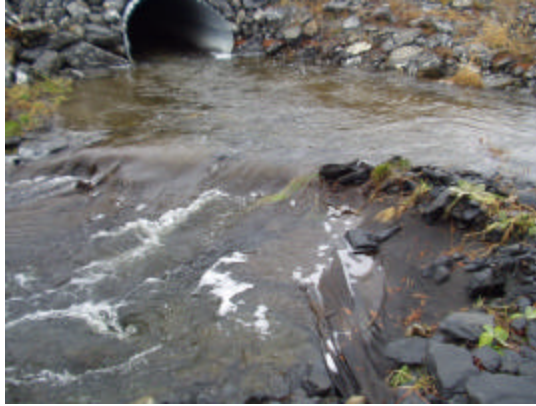
Wallagrass/Fort Kent 2003. Photo by R. Annis.

**Prior condition:** Existing twin 36" pipes, 50' long. Needed replacing because too short and too small. Design of this section of road grade raised so longer pipe needed. Area reviewed for drainage needs and required larger cross pipe to meet modern standards.

**Current condition:** Installed new 7' x 40" structural pipe plate arch about 95' long with approximate 6-8" hang at outlet because of shallow ledge. Raised downstream pool elevation to match culvert elevation by installing weir of non-woven geotextile fabric and rip rap in downstream pool. Weir increased volume of water in pool and raised stream elevation at outlet of downstream pool sufficiently to pass fish. Some rip rap scoured and moved around within downstream pool exposing small area of geotextile fabric. Has not compromised structural integrity of weir.

**Future action:** Will continue to monitor site conditions to assure weir continues to function as intended and allows fish to pass.

**Lessons learned:** Use larger rip rap or install more permanent structure such as concrete Jersey barrier weir.

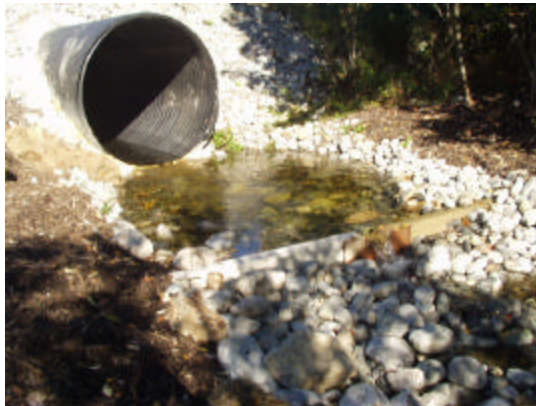
Carrabassett Valley 2003. Photo by R. Hodgman.

**Prior condition:** 84" multiplate corrugated pipe. Pipe in poor condition with holes at and below waterline. 6" vertical drop at outlet. 60' upstream of confluence with S. Branch Carrabassett River, 2.1 miles N of Kingfield town line (adjacent to North bound end of MaineDOT Rest Area). Discharges in excess of  $Q_{1.1}$  under hydrologic control of Carrabassett River (backwater condition). Substrates predominantly sand and pea-sized gravel upstream, hand to head-sized cobble downstream. Minor undercutting upstream. Two remnant and one active beaver dam upstream. No

**Current condition:** Grouted plastic slip liner with smooth interior and downstream pool/weir. Flat-bottomed v-notch weir (6") constructed of 2 concrete (Jersey) barriers, connected by reinforced concrete, embedded 3' into stream bank above normal water line of stream and minimum of 2' into substrate. Stone channel protection and drop-pools downstream of weir outlet. Weir structurally sound, notch drop approximately equal to that at outlet. NW side of structure has settled approximately 1.5", allowing overtopping flow at moderate discharge levels. Downstream drop-pools in fair condition. During 2 post-construction site visits, rocks forming pools were relocated to improve pool configuration.

**Future action:** Two years of post construction monitoring.

**Lessons learned:** In coarse bed materials, bedding of structure with underwater fills may be necessary. Compacting bedding substrate should be standard procedure.
